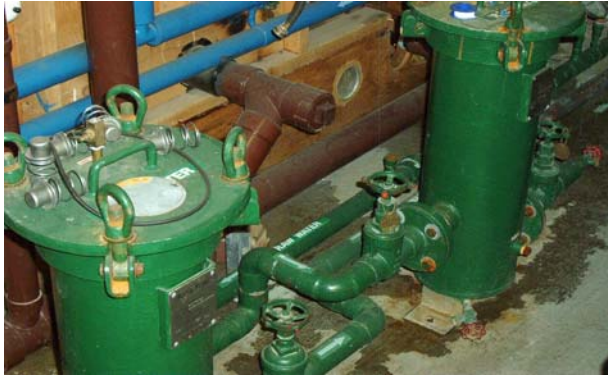
Micron filter units, replaced filters in both. Water on the floor is the source of ice under building. Water is from various leaks.

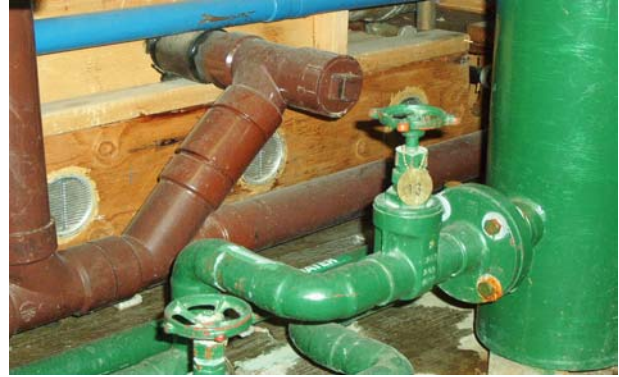
Another view of water on floor from leaks several different leaks that have been repaired.

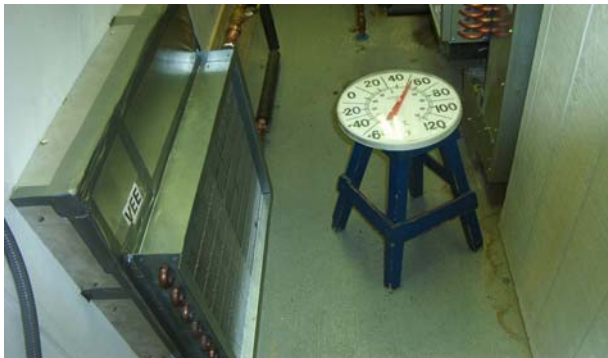
Motorized grill and pre heat coil for dryer make up air. Temperature of air shown. Outside temp was 0 degrees F.

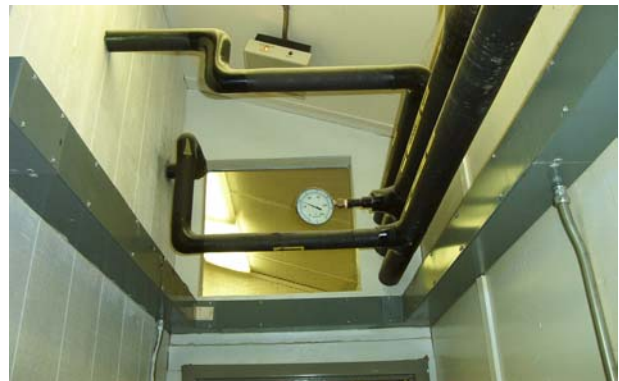
Air entered dryer area prior to installation of motorized grill, we blocked this air passage with plywood.

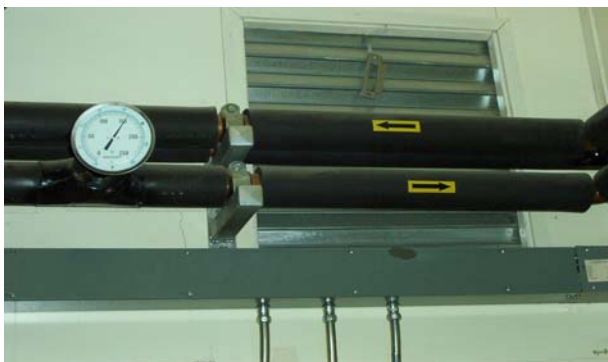
Air passage from boiler room to plant. This allowed makeup air to dryers prior to installation of motorized grill. We closed this

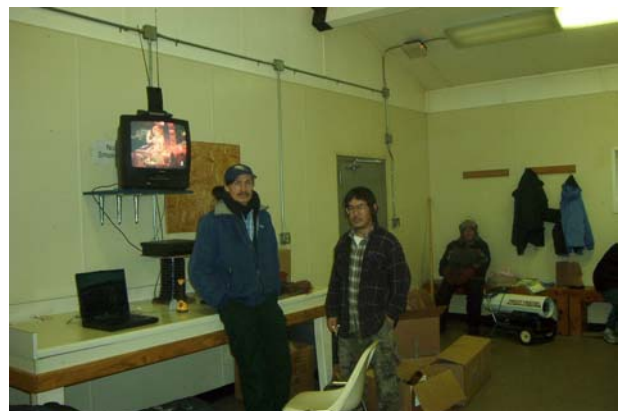
Window was covered with plywood, we replaced window with new one.
